Brownhill Creek Recreation Park

Kaurna shelter tree management plan

25th May 2018

Kym Knight
Consulting Arborist
Tree Environs Pty Ltd

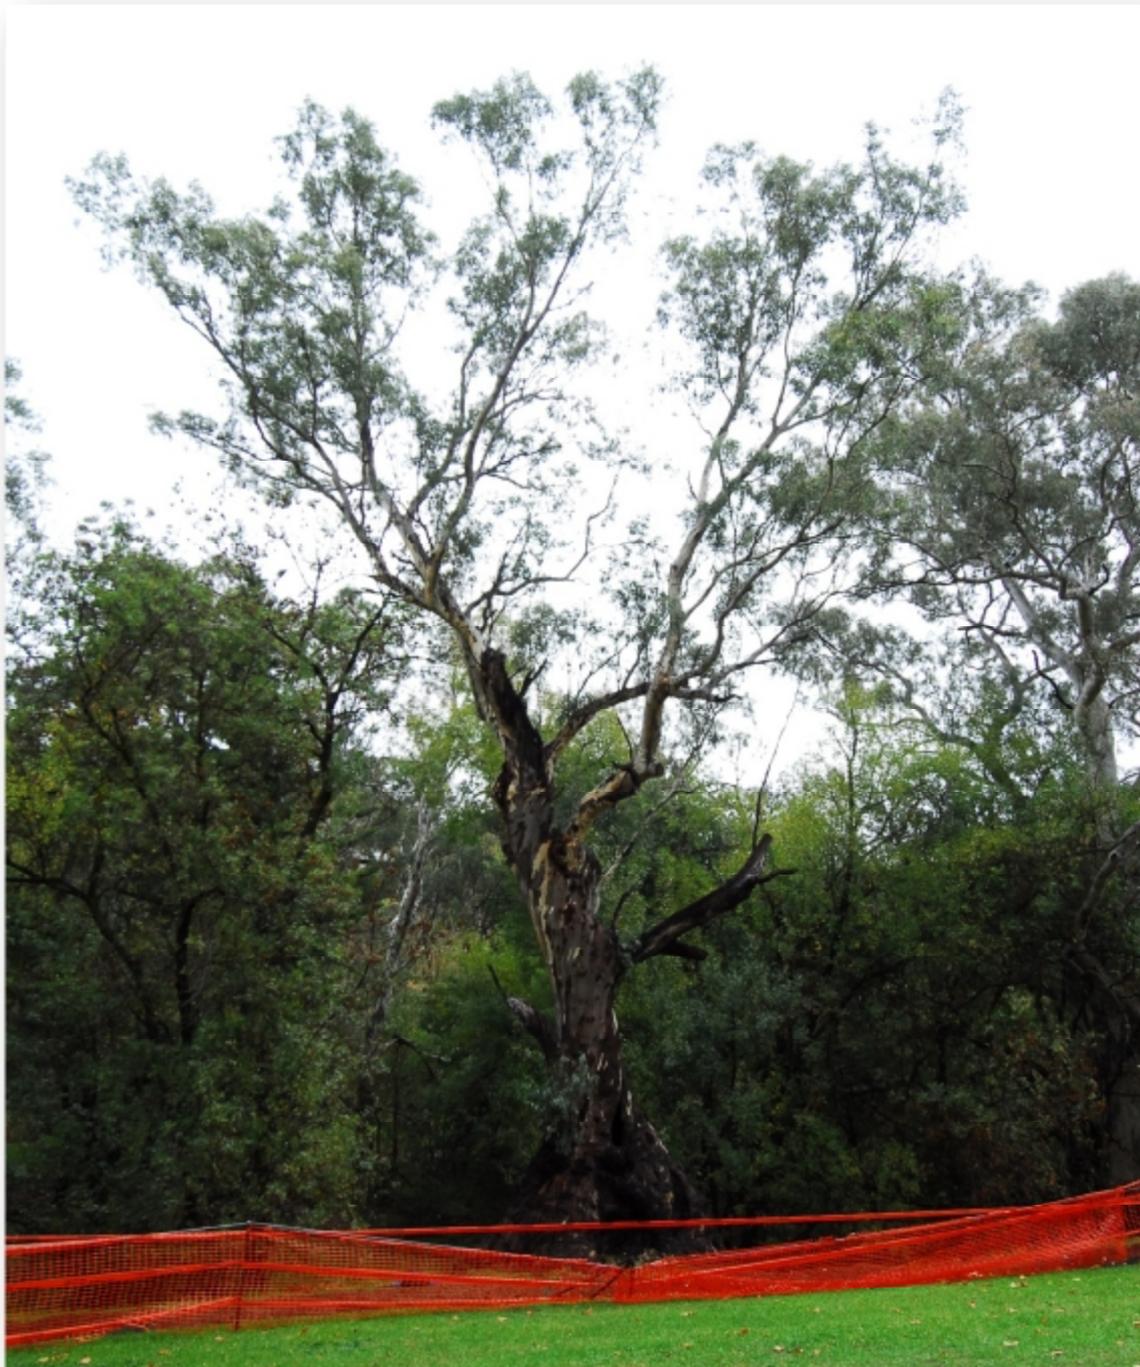
Standing on the edge of Brownhill Creek, the Kaurna shelter tree remains largely surrounded by woody weeds. The recent trenching (2018) occurs immediately behind the bunting in the above image.

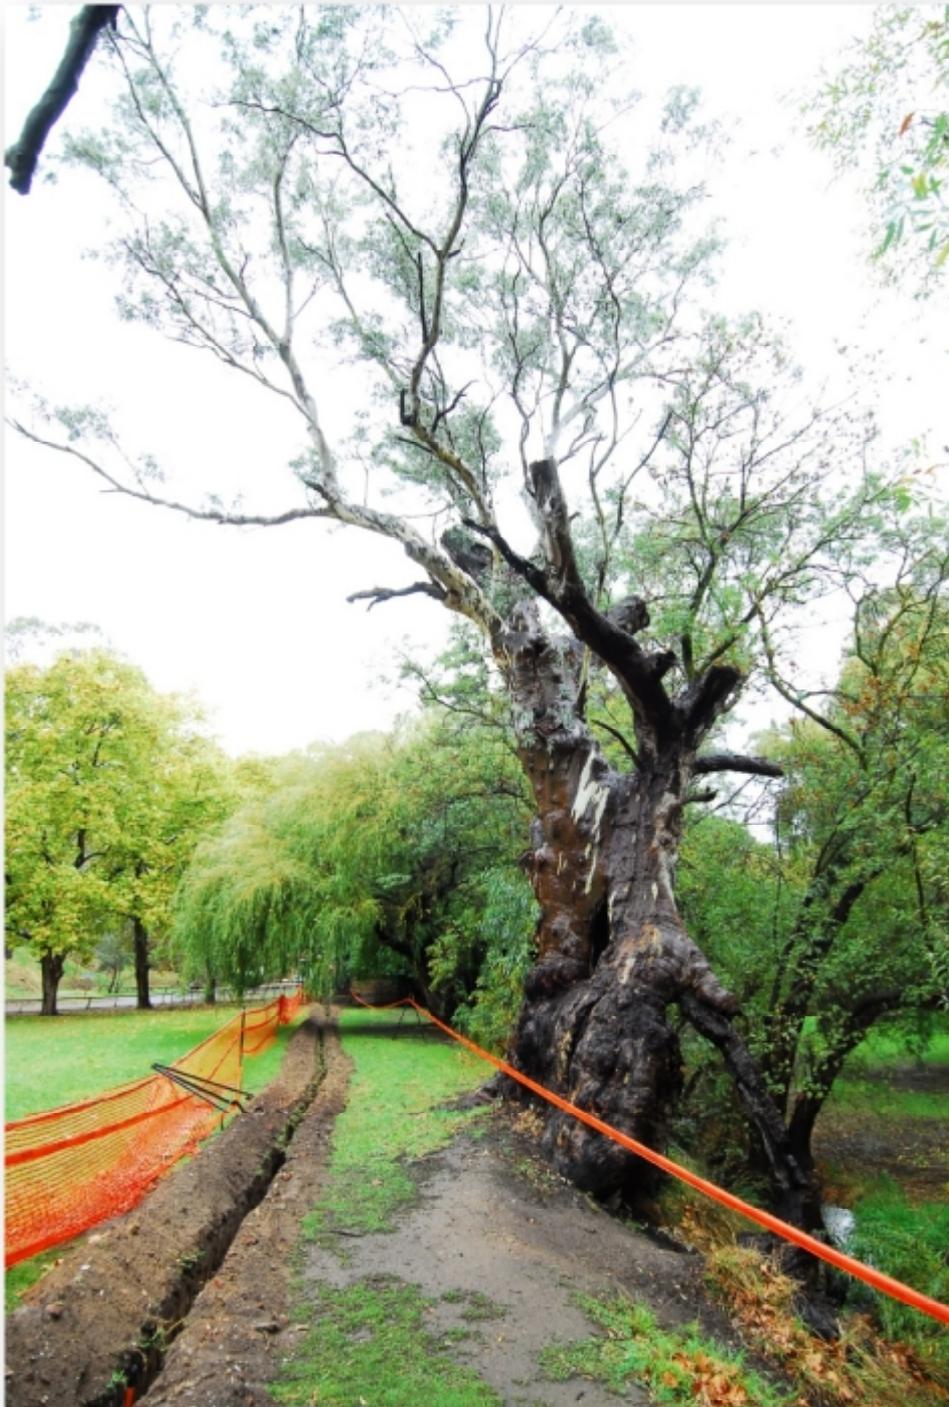
Recent trenching near the Kurna shelter tree. Fortunately no major root damage has been inflicted by this process. It is unlikely there will be any ongoing health consequences associated with the trenching.

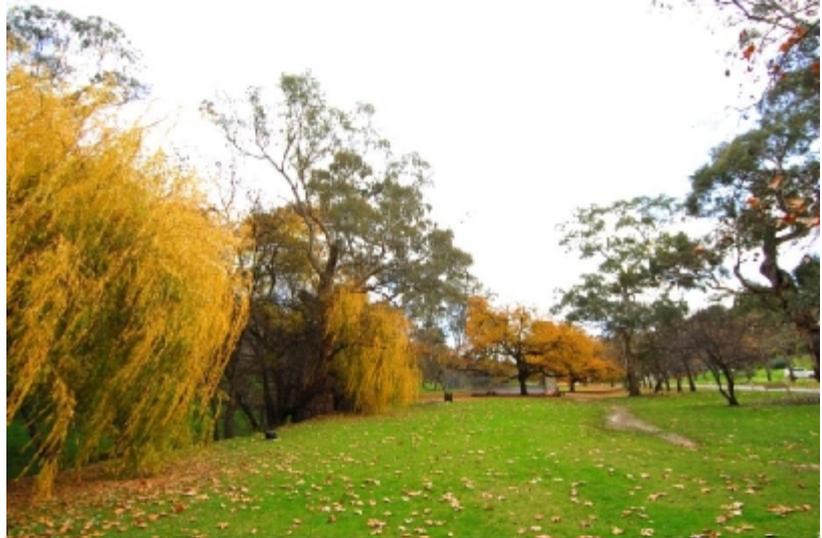
Image 5: The large expanse of turf east of the tree degrades the quality of the growing environment.

A compacted gravel layer beneath the turf is likely to be impervious in places. The gravel layer is visible here where an eroded central pathway is exposed.

4. Control turf <ul style="list-style-type: none"> · Kill the turf grass adjacent to the management area using glyphosate at recommended rates at least 8 weeks prior to ripping treatment. 	High	Year 1

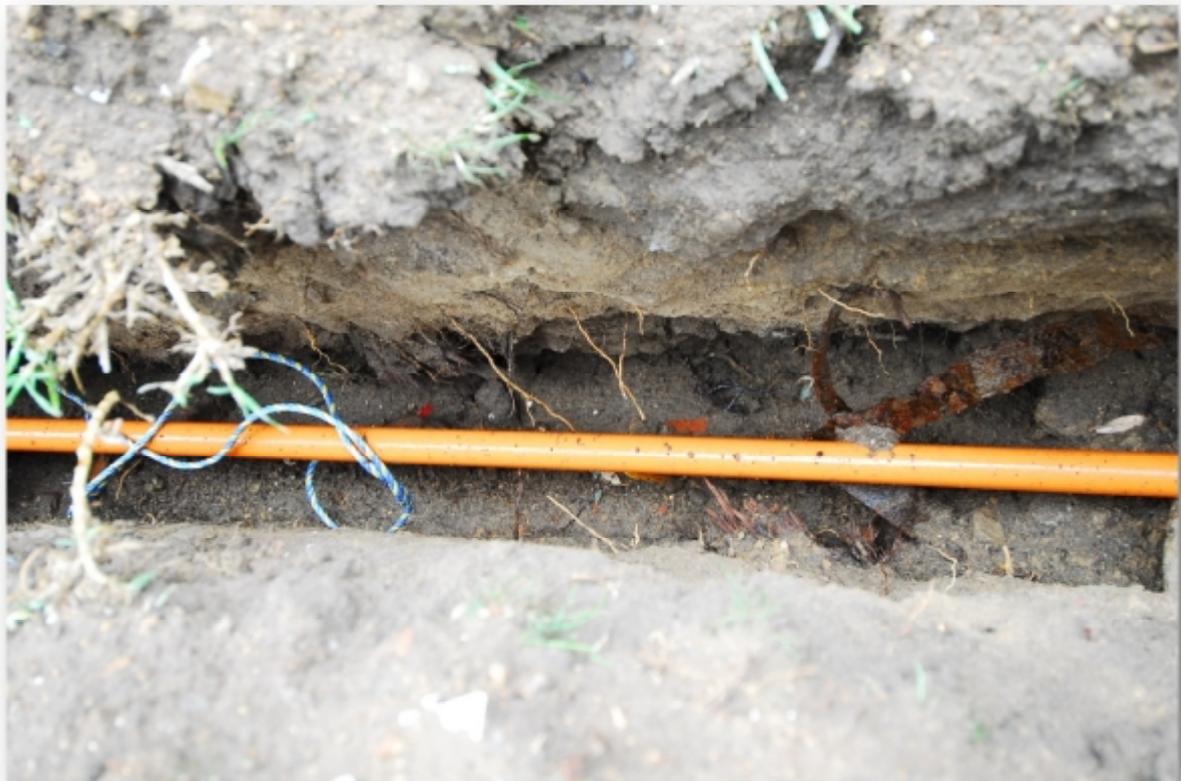
Image above: The trenching revealed layers of imported gravel and soil and well as buried debris within the root zone east of the tree.

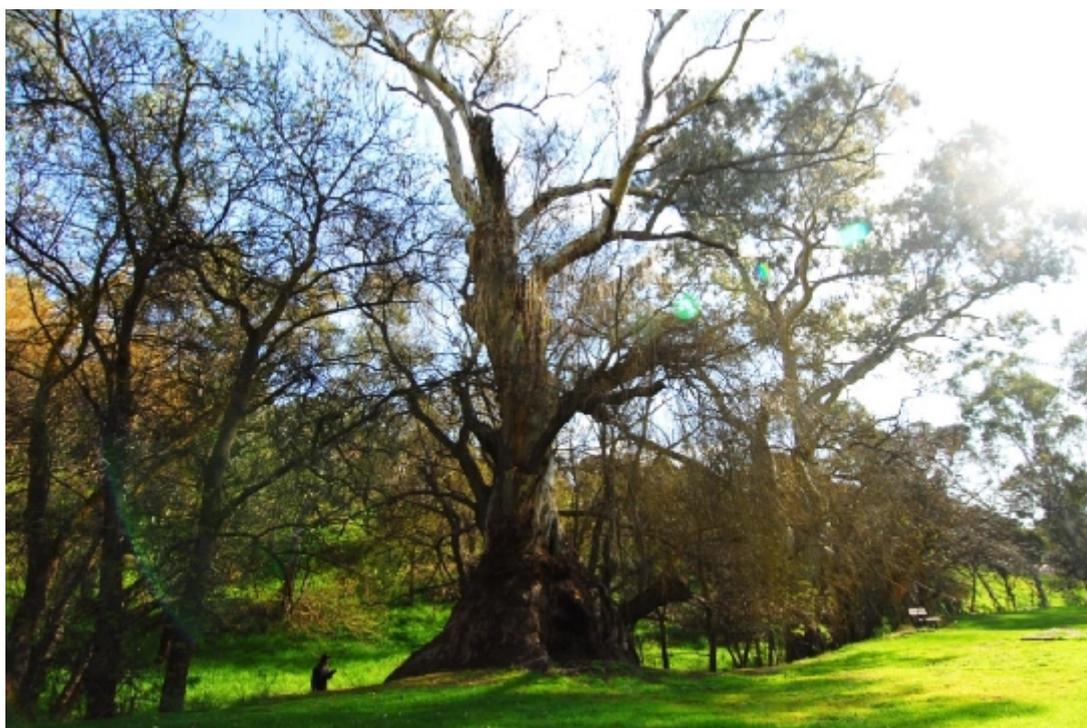
Image above: The ~250mm diameter branch overhanging the turf area to the north is the largest branch most likely to fail into the target zone. The QTRA assessment conducted on this tree indicates the risk posed by this branch is low. No action can be justified at this time to further mitigate and already low risk. NOTE: significant changes to site occupancy levels may increase the risk of harm posed by the tree.
